AL FATAH PIPE RIVER CROSSING
AL FATAH, IRAQ

SIGIR PA-05-010

MARCH 7, 2006

Al Fatah Pipe River Crossing in Al Fatah, Iraq

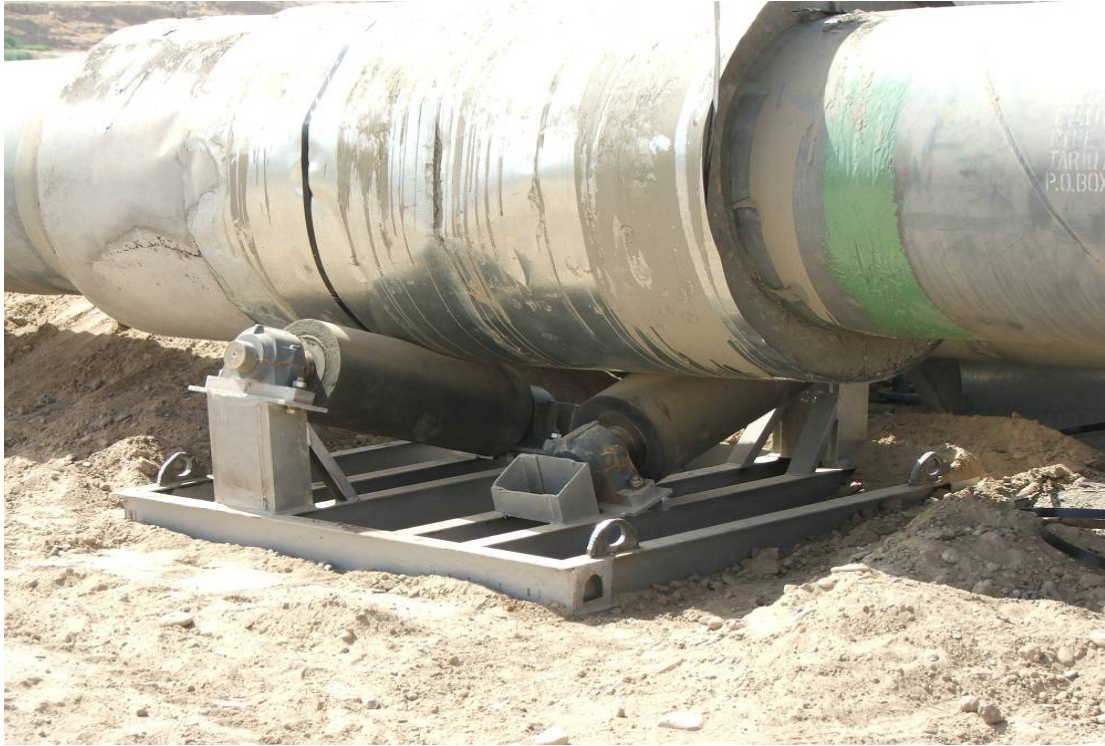
strung on the east side of the Tigris River. In addition, the welding was complete on the nine pipelines to be installed in the Tigris River. The 40 inch pipeline was placed on rollers in preparation for the first pull across the Tigris River. Site photo 1 shows a 40-inch pipeline on rollers. The welded pipeline strings shown are 1241 feet in length. The work observed was consistent with the requirements of the PSSR.

Site Photo 1: 40-Inch Pipeline on Rollers

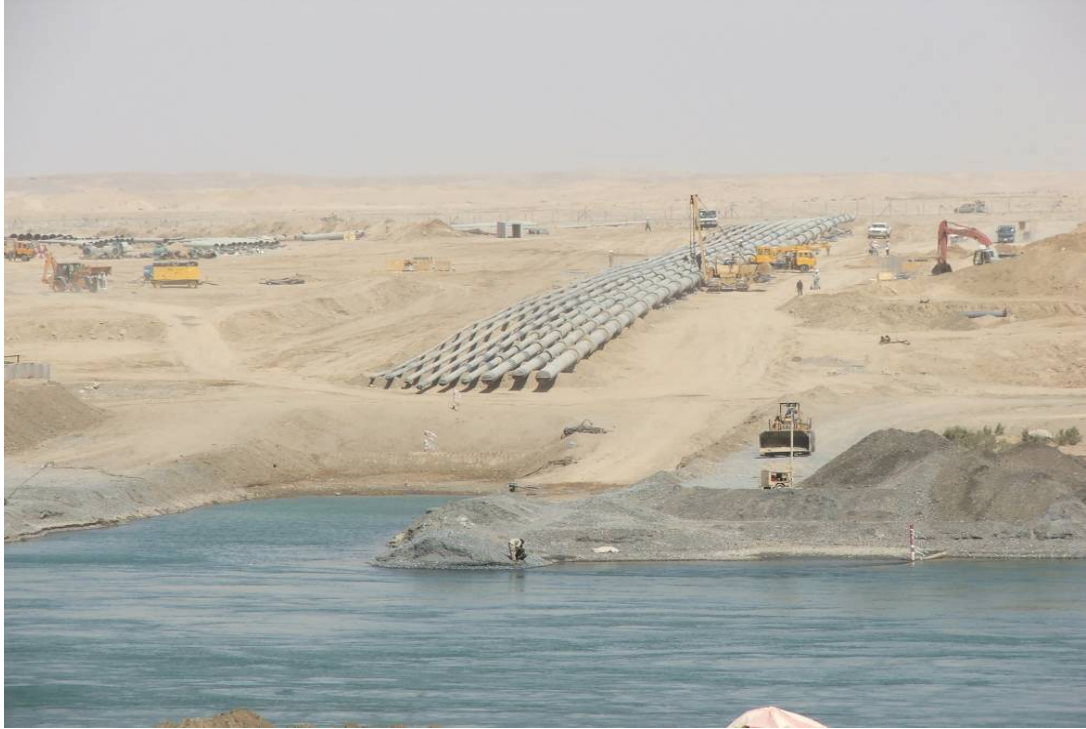
Design specifications required 100 percent radiograph (X-ray) examination of welds and exterior treatment with field coat epoxy to inhibit corrosion. All nine pipelines that will be placed in the river crossing trench will require concrete encapsulation to increase the density of the pipeline so that the pipeline remains submerged in the trench particularly when empty of oil. Site photo 2 shows pipes staged on the east bank of the Tigris River. Site photo 3 shows a section of pipe encapsulated in concrete. The site assessment verified that radiograph examination of the pipeline, application of field coat epoxy, and concrete encapsulation of the pipe was ongoing. The work observed was consistent with requirements of the design specifications.

Site Photo 2: Pipes Staged on Tigris River East Bank

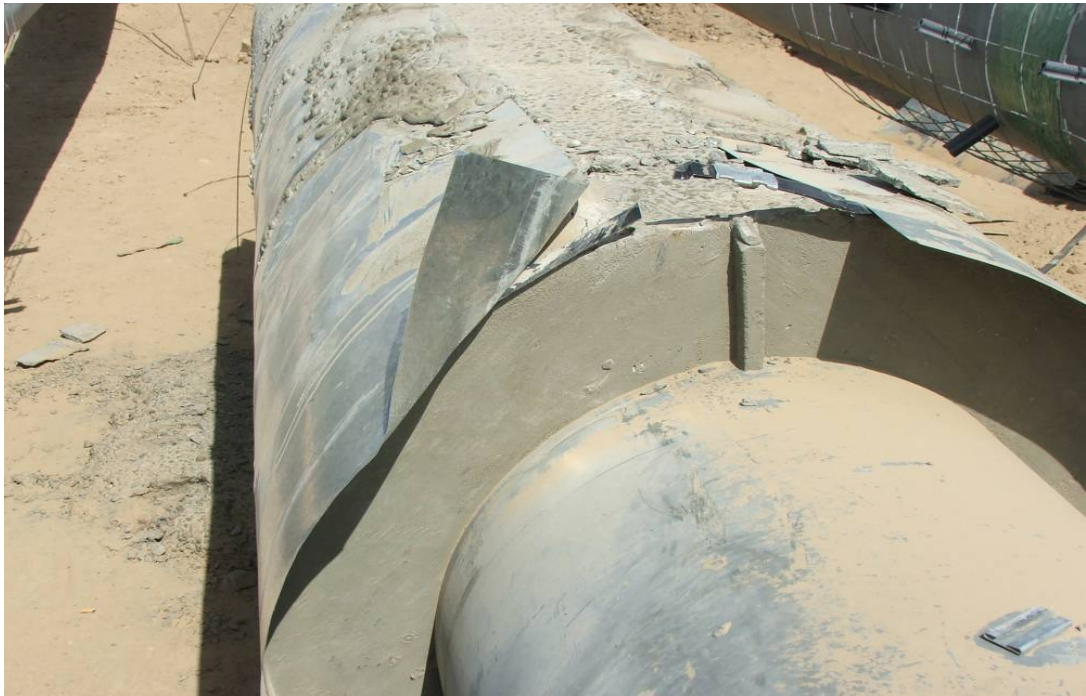
Site Photo 3: Section of Pipe Encapsulated in Concrete

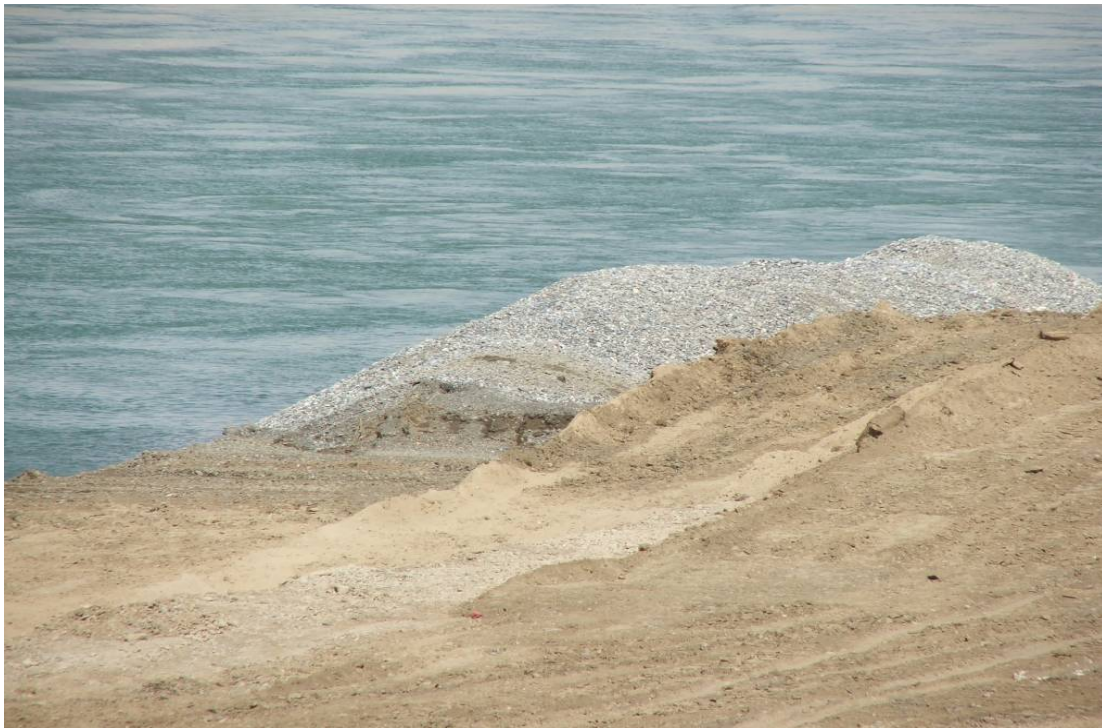
The dredging of the small diameter gravel and rock was reported to be complete. The gravel and small rock in the Tigris River were removed by dredging. Dredging equipment, a dredging barge, and spoil piles were observed on site, indicating dredging operations were performed, but measurements of the underwater excavation were not verified. Site Photo 4 shows river rock and gravel dredged from the riverbed. Site Photo 5 shows an excavator for dredging on the Tigris River.

Site Photo 4: River Rock and Gravel Dredged from River Bed

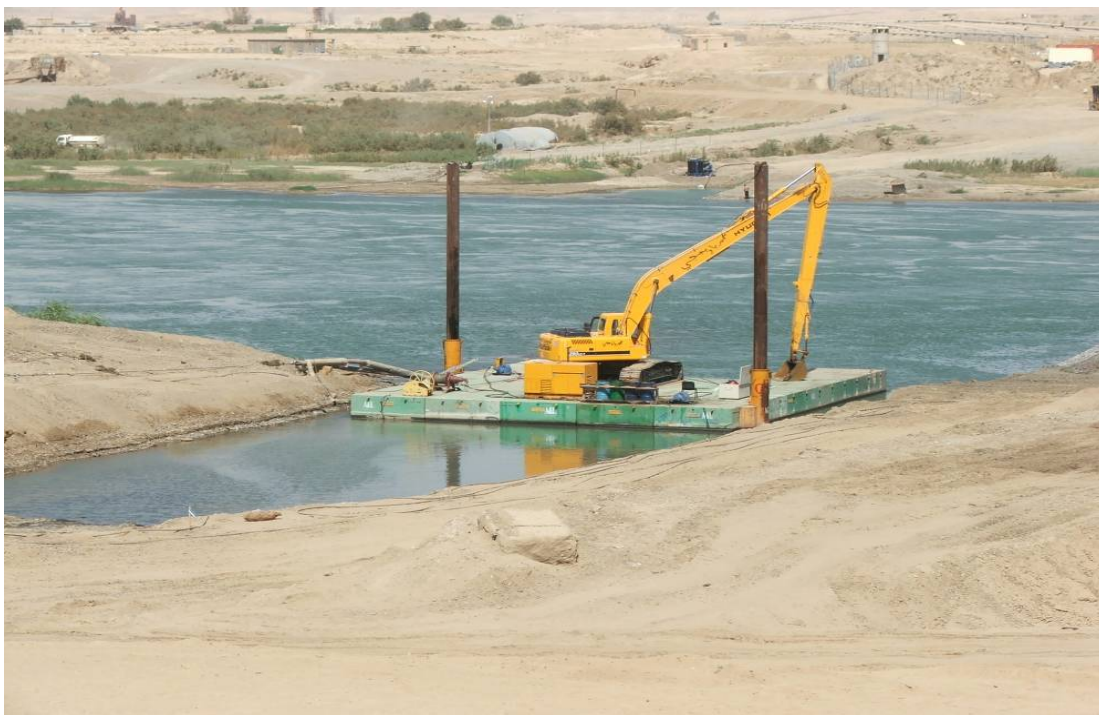
Site Photo 5: Excavator for Dredging on Tigris River

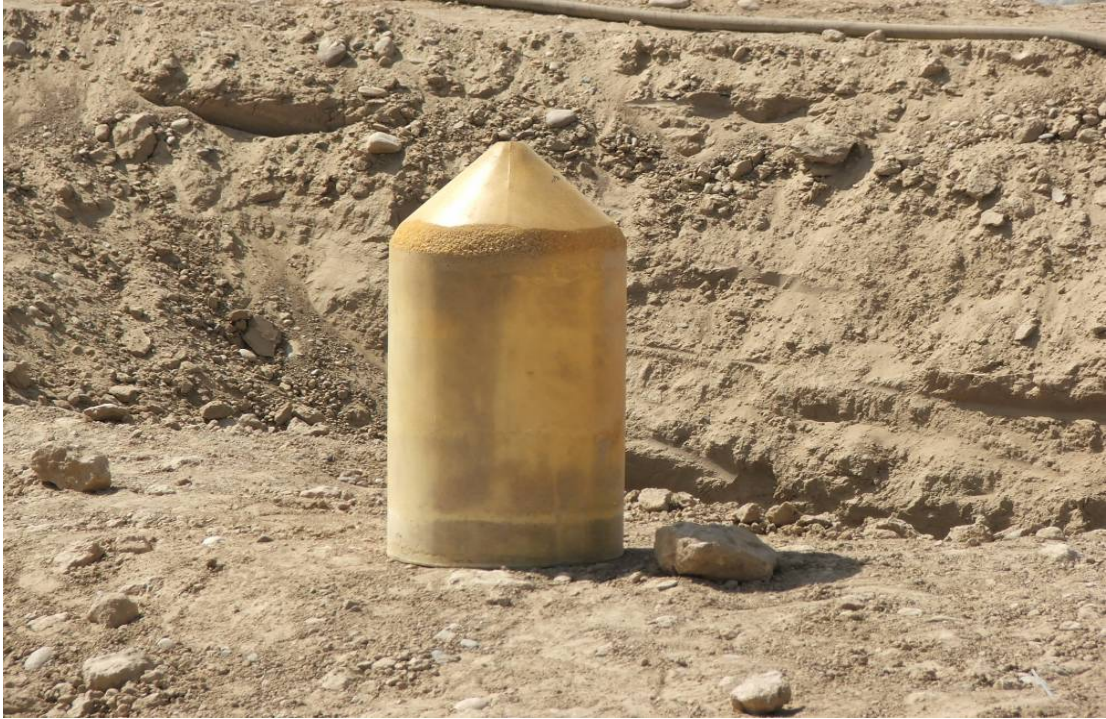
² Pipeline pigging was developed in the 1950s in the United States to clear debris from crude oil pipelines. It is now used around the world in all types of pipelines, but it is most commonly used in the oil, gas and petrochemical industries. A pig acts like a free moving piston inside the pipeline, sealing against the inside wall of the pipeline. Pigs can perform a number of tasks including cleaning debris from the line, the removal of residual product and gauging the internal bore of the pipeline. For an illustration of a 20-inch pig, see Site Photo 6. The pigging of a pipeline will increase the lifetime and throughput of a pipeline. For an illustration of a pipe ready for pigging, see Site Photo 7.

Site Photo 6: 20-Inch Pig

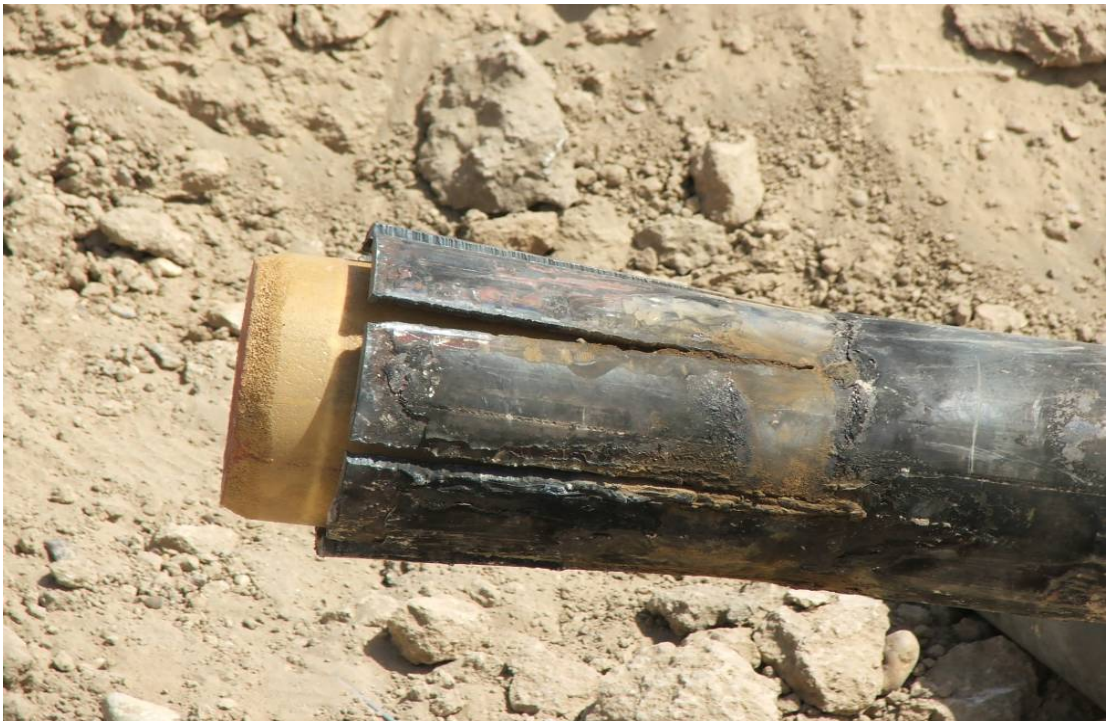
Site Photo 7: Pipe Ready for Pigging

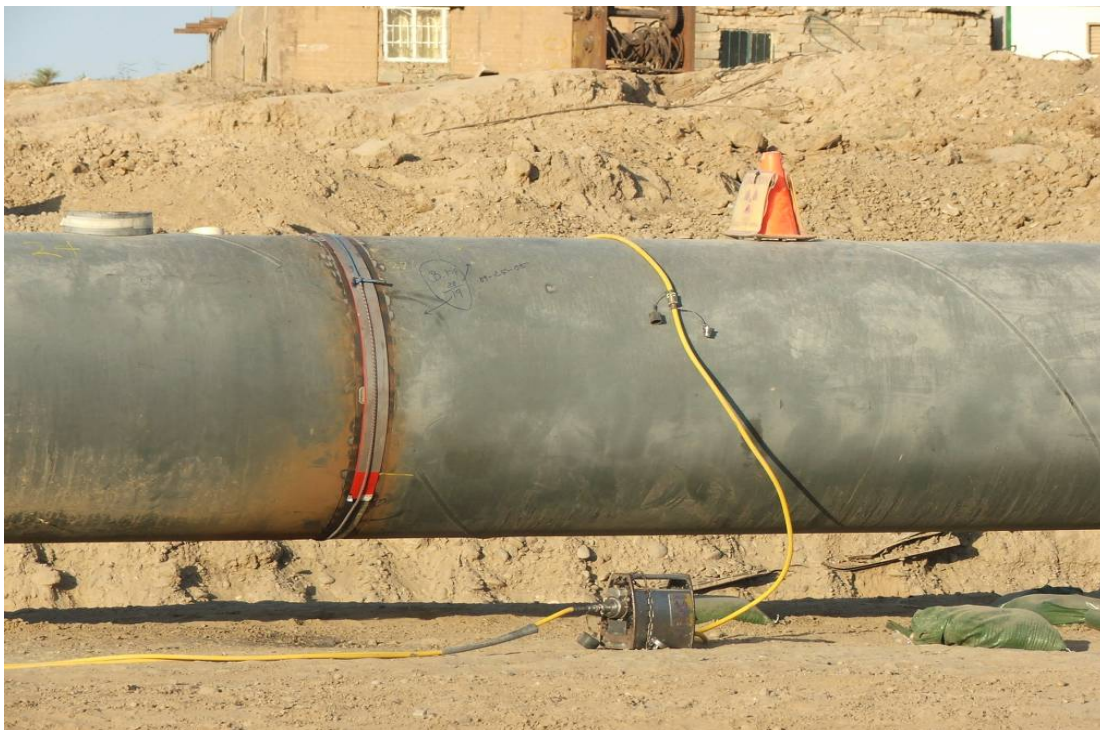
- **Construction Conformity:** USACE Project Engineer advised that all welds are radiographed (X-rayed) to ensure adequate pipe strength and seal, as required in the contract. The assessment team observed radiography testing and analysis on site. As a result, injury risk to personnel working around the pipe following commissioning will be decreased, while product loss via leaking will be avoided. The radiography process produces a filmstrip unique to each weld. For an illustration of a radiography test in progress on a 40-inch pipe weld, see Site Photo 8. Accordingly, each filmstrip is retained and logged by weld number to track deficiencies and corrections. To ensure effective monitoring of welder performance, each weld is marked with a number unique to the welder that performed the work. For an illustration of a pipe treated with an epoxy protective sealer following the completion of an electronic Holiday Test (porosity detection) that showed where the factory protective covering was thin or damaged, see Site Photo 9. For an illustration of how spots needing protective epoxy treatment are prepared and cleaned with a sand blaster, see Site Photo 10. Such processes ensure proper construction and long term serviceability.

Site Photo 8: Radiography (x-ray) Test In Progress on 40-inch Pipe Weld

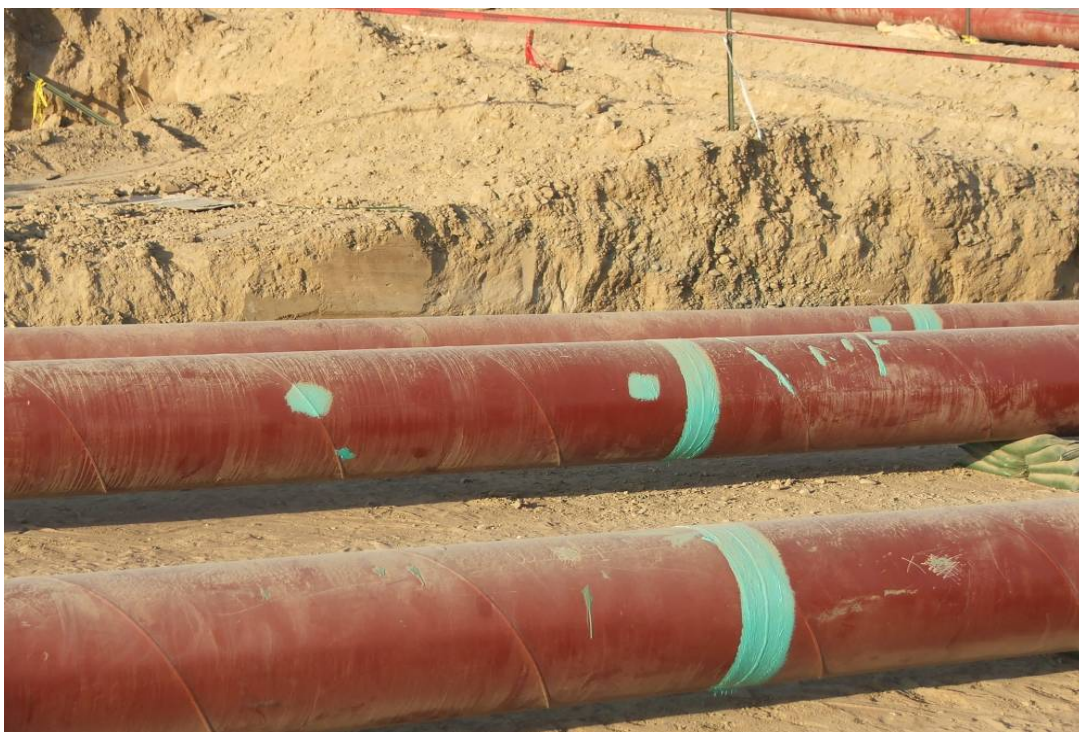
Site Photo 9: Corrosion Control Epoxy Following Holiday Test

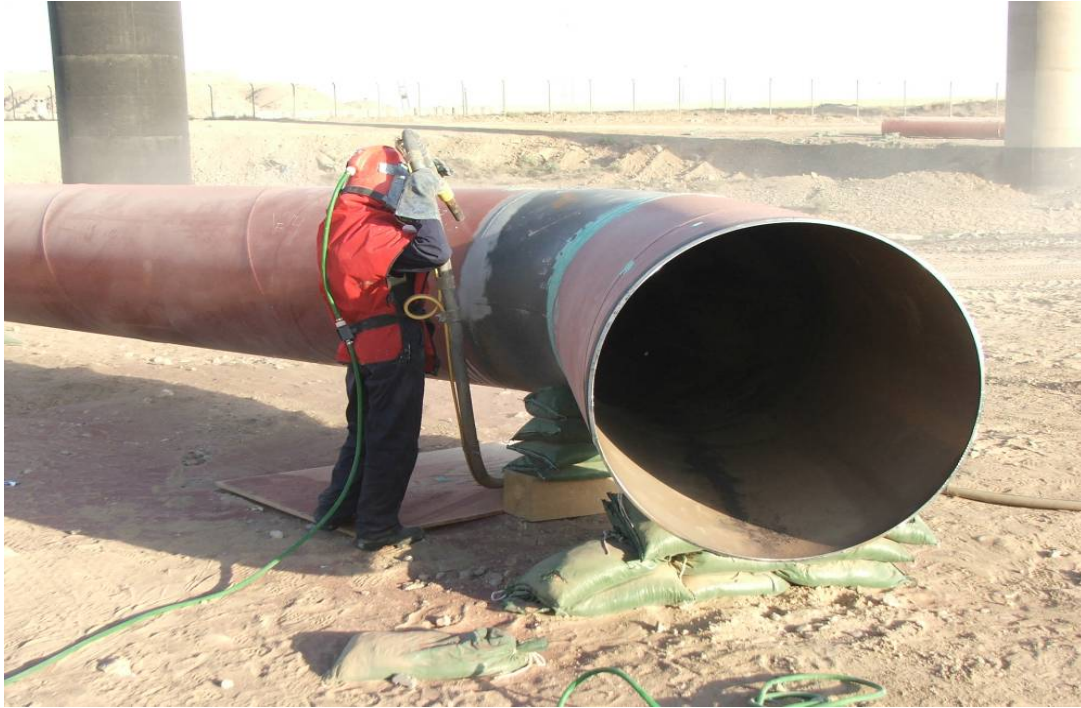
Site Photo 10: Sand Blasting to Prep Pipe for Protective Epoxy Coating

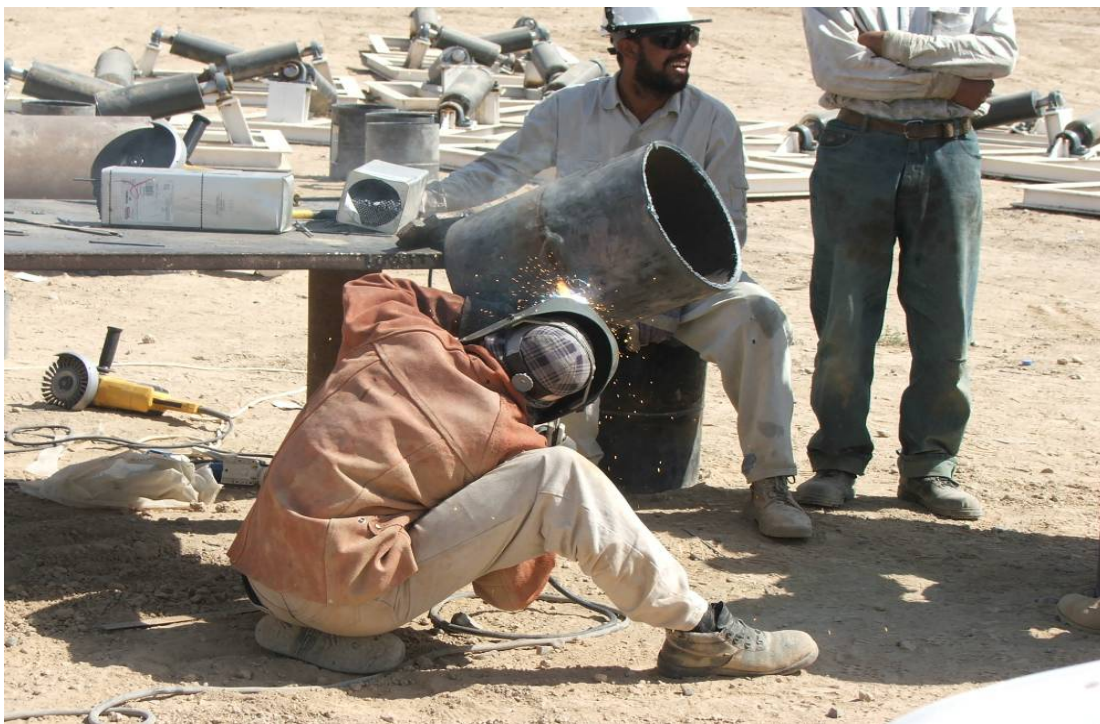
- **Welder Testing:** The USACE Project Engineer and the contractor's QC Inspector advised that all welder applicants are field tested to determine whether they possess the skills required. The assessment team observed such a test while on site. For an illustration of an Iraqi welder applicant nearly finished with a welding test, see Site Photo 11. Welds must pass visual, radiographic, and strength tests before a welder can be hired by the contractor. Standards are strict and retesting is not allowed. For an illustration of a weld test that passed visual inspection by the contractor's welding supervisor and was subsequently cut/prepared for destructive testing, see Site Photo 12.

Site Photo 11: Iraqi Welder Applicant Demonstrated Skills

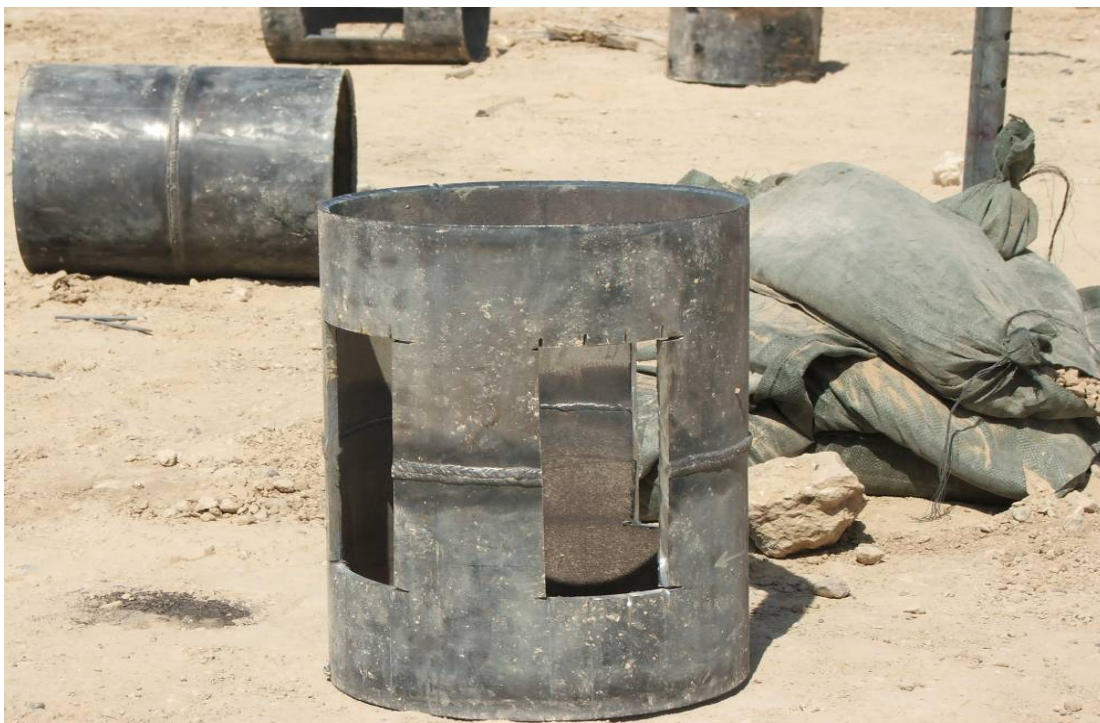
Site Photo 12: Test Section Cut for Destructive Test

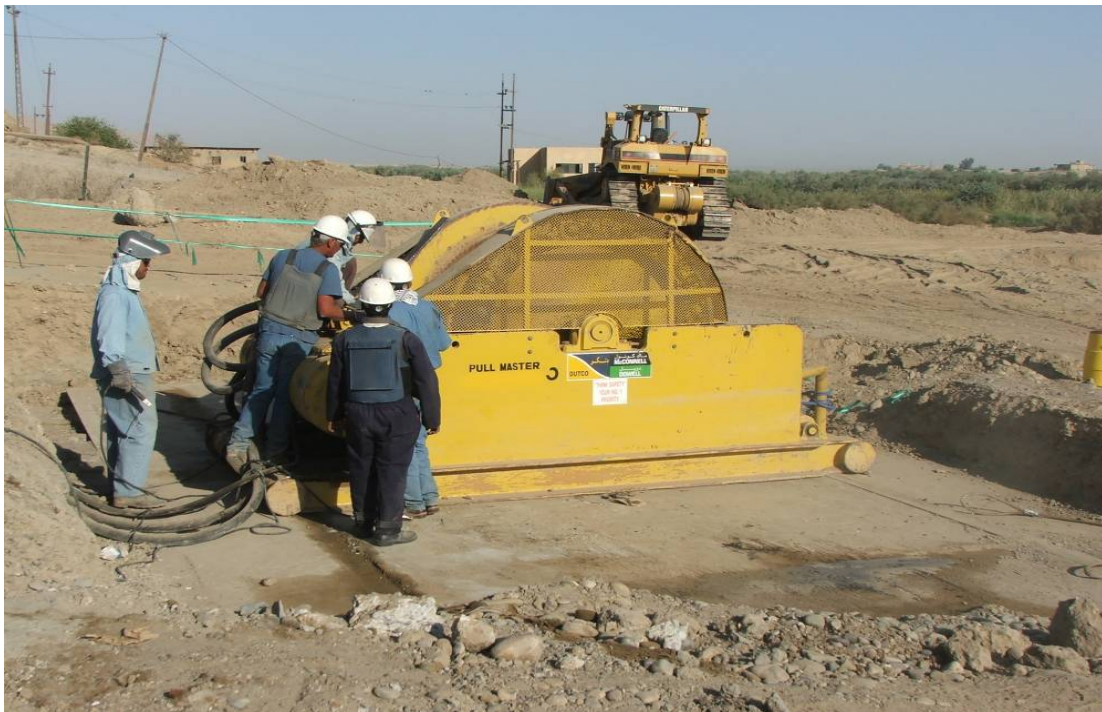
In Site Photo 13, one of the contractor's foremen oversees the changing of the steel winch cable from 1.5 inches to 2 inches to ensure enough cable strength to pull pipes across the river.

Site Photo 13: Field Supervisor Oversees Winch Cable Change-Out

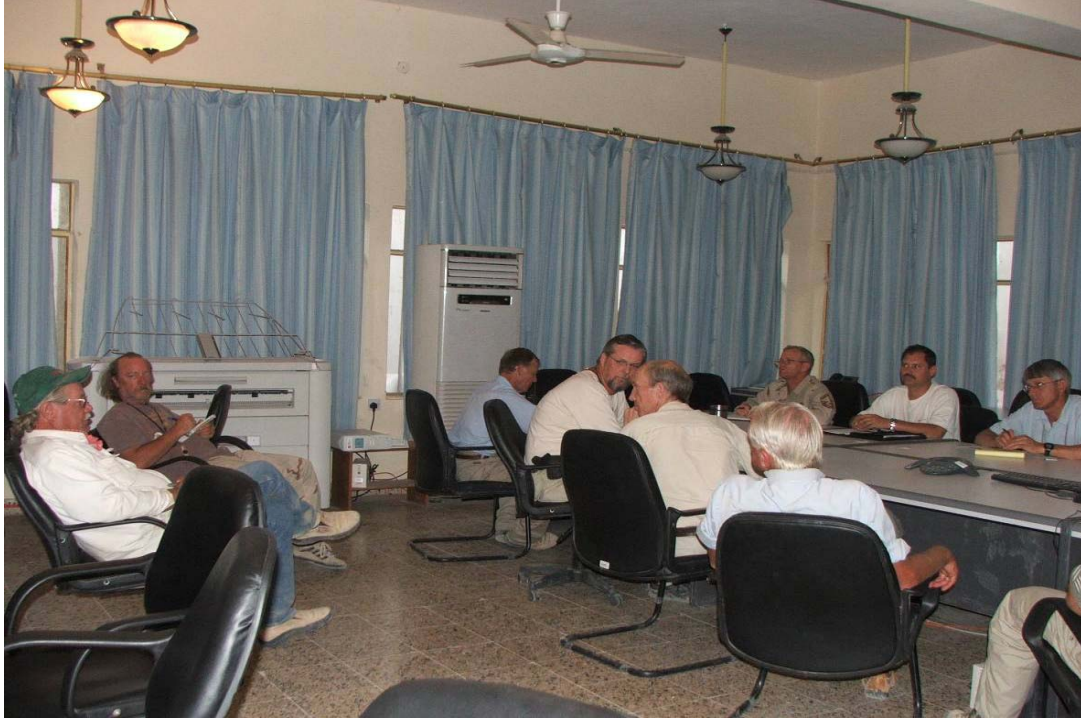
Site Photo 14: Contractor and Government Managers Conduct End of Day Meeting

- **Teamwork:** During the site visit, the SIGIR team observed that key contractor and government managers conduct an end of business day meeting to discuss the day's accomplishments and problems. For an illustration of a contractor and government managers conducting an end of day meeting, see Site Photo 14. Present at the meeting were the senior on-site manager for both the contractor and subcontractor; subcontractor's construction superintendents and welding supervisor; prime contractor's logistics, security, and safety managers; and the U.S. Government's Resident Engineer, and at least one of the two Construction Representatives. Each meeting observed included a report of the number of welds completed, tested, and accepted. The Quality Management program was more effective because of the nightly meetings.
